POLY-LINED PIPE

## Zimmatic Polyethylene-lined pipe

### Keeps water flowing even in extreme conditions.

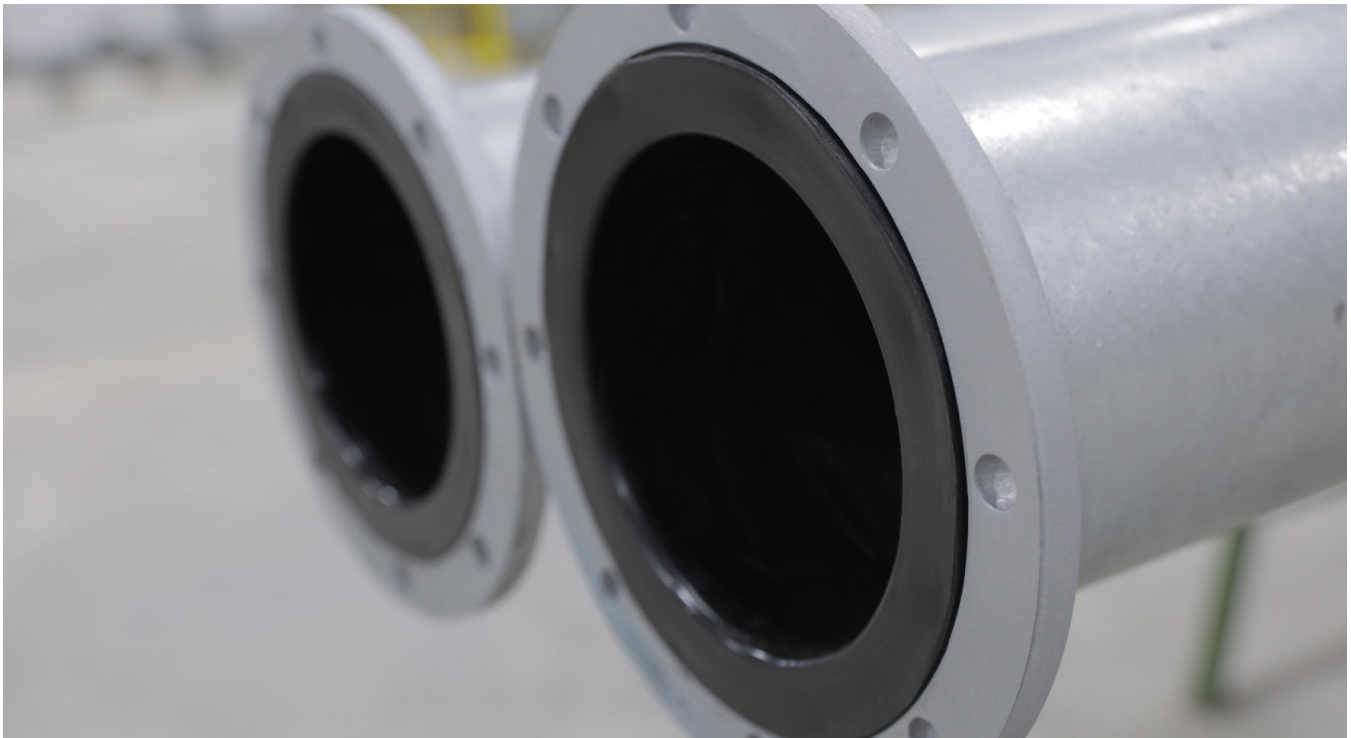
- Recessed poly flange allows for positive steel flange contact.
- No gap between joint flanges results in improved strength and span consistency.
- New manufacturing process increases friction between the poly liner and the steel pipeline, reducing lateral movement from temperature fluctuation.
- Less stress, less corrosion = longer leak-free lifespan.
