HSST-1/ CC-141

- MAX-Tension™ Median

Name of system: MAX-Tension™ Median
Type of system: Crash Cushion
Test Level: MASH Test Level 3
Testing conducted by: Safe Technologies, Inc.
Date of request: November 3, 2017
Date initially acknowledged: February 10, 2017
Date of Final Package: November 8, 2017

Request for Federal Aid Reimbursement Eligibility of Highway Safety Hardware

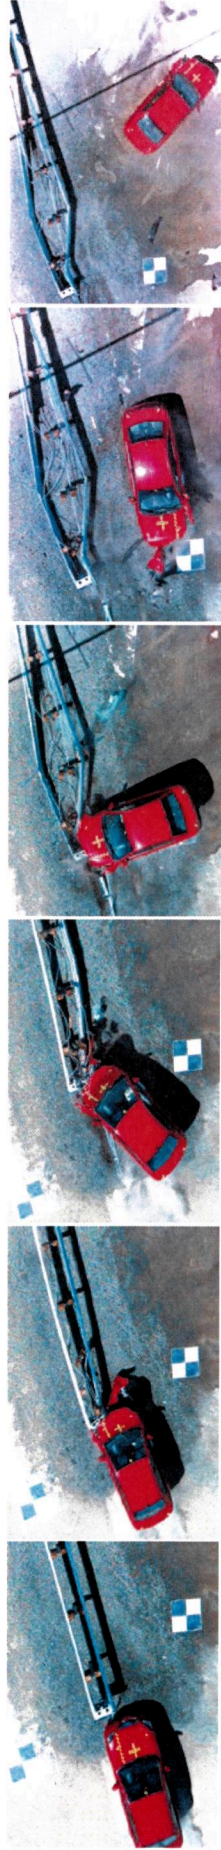
General Information
 Test Agency..... SAFE TECHNOLOGIES, INC.
 Test Number..... MMT330-C3
 Test Designation..... MASH 3-30
 Date..... 7/14/2017

Test Article
 Name..... LTS, MAX-Tension Median
 Type..... Guardrail End Terminal, Median
 Installation Length..... 155.1 ft (47.3 m)
 Width..... 28.4 in (721.4 mm)
 Height..... 31 in (787 mm)

Impact Conditions
 Speed..... 62.0 mph (99.8 kph)
 Angle..... 0.0 deg
 Location / Orientation..... 1/4 Offset

Post Impact Trajectory
 Vehicle Stability..... Satisfactory
 Longitudinal Stopping Distance..... 88.25 ft (26.9 m)
 Vehicle Snagging/Pocketing..... None

Occupant risk Values
 Longitudinal OIV..... 40.0 ft/s (12.2 m/s)
 Lateral OIV..... 1.6 ft/s (0.5 m/s)
 Longitudinal ORA..... 9.3 g's
 Lateral ORA..... 7.5 g's
 THIV..... 41.0 ft/s (12.5 m/s)
 PHD..... 10.0 g's
 ASI..... 1.84

Test Article Deformation..... Moderate
Test Article Deflections
 Longitudinal system stroke..... 6.92 ft (2.11 m)
 Permanent lateral deflection..... 23.4 in (0.595 m)
 Dynamic lateral deflection..... 26.0 in (0.660 m)

Vehicle Damage
 VDS..... 11-FL-5
 CDC..... 11FLEW3
 Interior Deformation..... Minimal

Required Test Number	Narrative Description	Evaluation Results
3-30 (1100C)	<p>The MAX-Tension Median end terminal satisfied the MASH structural adequacy criteria for its intended function as an end terminal. The test article captured the 1100C vehicle in a controlled manner. The vehicle did not penetrate, underide, or override the installation. The test article exhibited controlled permanent and dynamic deflection in the test.</p> <p>All of the occupant risk criteria were satisfied in testing the MAX-Tension Median end terminal. Theoretical occupant impact velocities in the longitudinal and lateral directions met the limit of 40.0 ft/s (12.2 m/s). Ridedown accelerations in the longitudinal and lateral directions were well below the preferred limit of 15.0 G. There was no test article debris detached during the test.</p> <p>Vehicle occupant compartment deformations were well below allowable limits. There were no intrusions into the occupant compartment. The test vehicle remained upright during and after the collision with minor roll and pitch.</p> <p>The MAX-Tension Median end terminal was judged as satisfying the applicable MASH vehicle trajectory criteria.</p> <p>The terminal was judged to have successfully met all of the evaluation criteria for MASH Test 3-30.</p>	PASS
